**PUBLIC WORKS
CENTER
YOKOSUKA, JAPAN
FLEET MOORINGS
UNDERWATER
INSPECTION
REPORT**

SEPTEMBER 1983

OCEAN ENGINEERING
AND CONSTRUCTION PROJECT OFFICE
CHESAPEAKE DIVISION
NAVAL FACILITIES ENGINEERING COMMAND
WASHINGTON, D.C. 20374

FPO-1-83 (25)

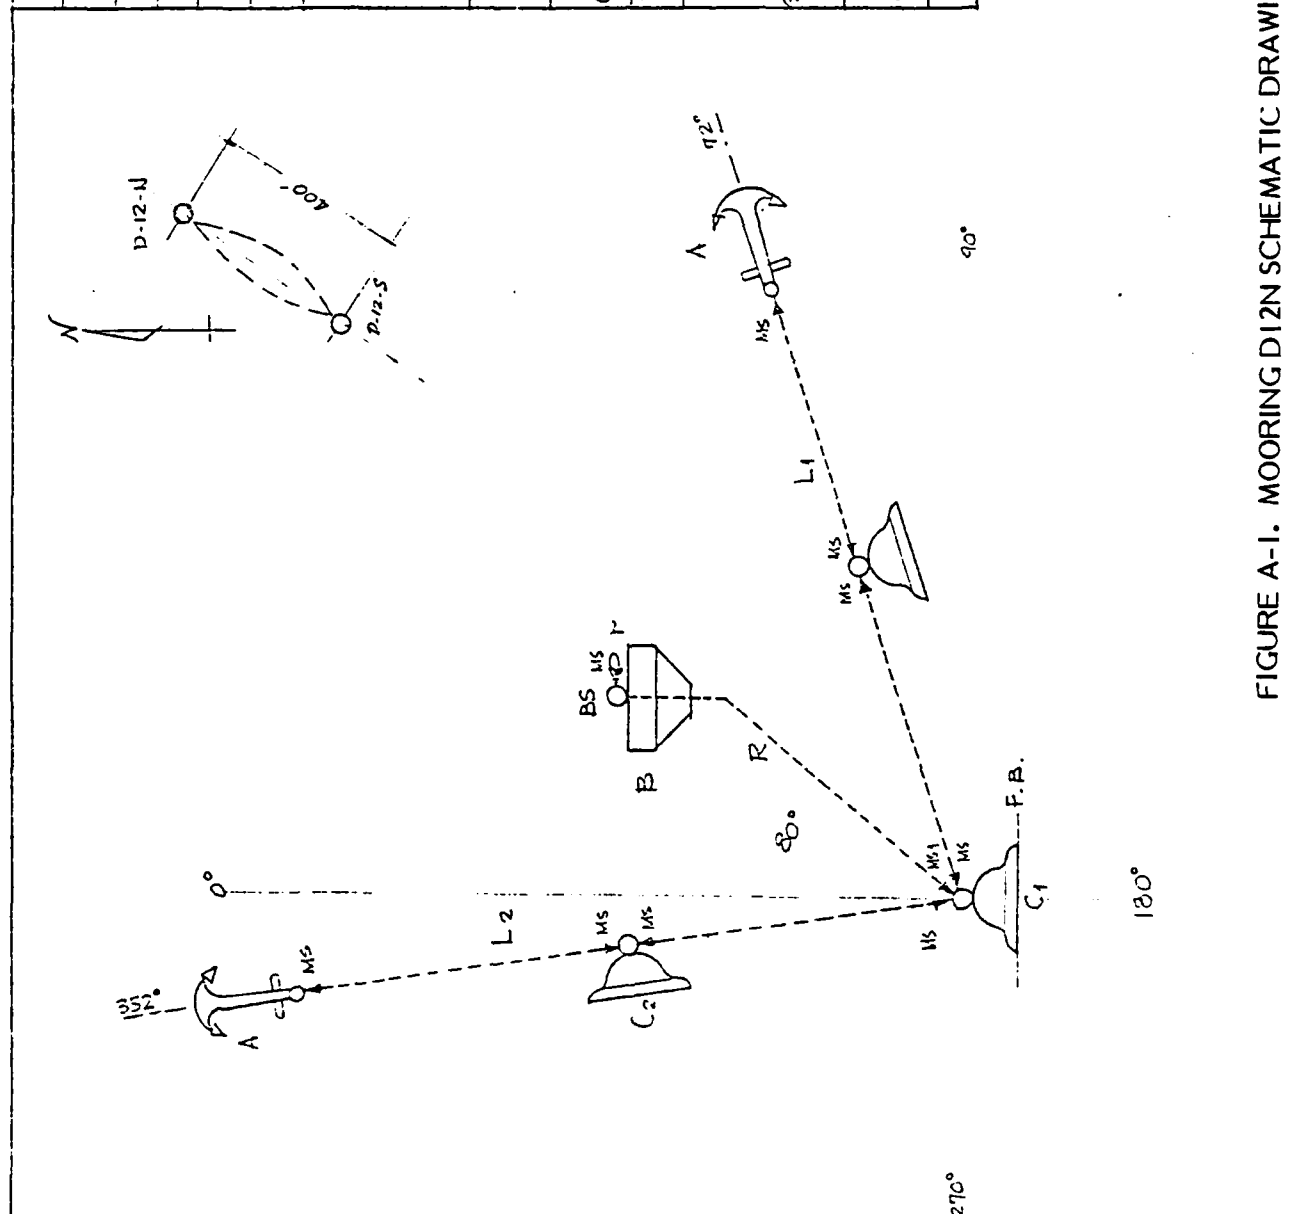
FIGURE A-1. MOORING D12N SCHEMATIC DRAWING

This is a large Japanese-built drum-type buoy with a hawsepipe. The buoy was fiberglass coated, but the fiberglass is badly chipped. The hull of the buoy below the waterline is covered with several inches of heavy marine growth. The top of the riser measured greater than 90 percent of its original wire diameter but is moderately rusted. The chafing rail is badly dented.

This mooring is in good condition.

As-built information contained in Figure A-1 reveals that the legs of this mooring were 2-1/2 inch wire diameter when installed. A class A mooring requires ground legs of 2 3/4-inch diameter. Therefore, recommend that this mooring be reclassified from a class A to a class B mooring.

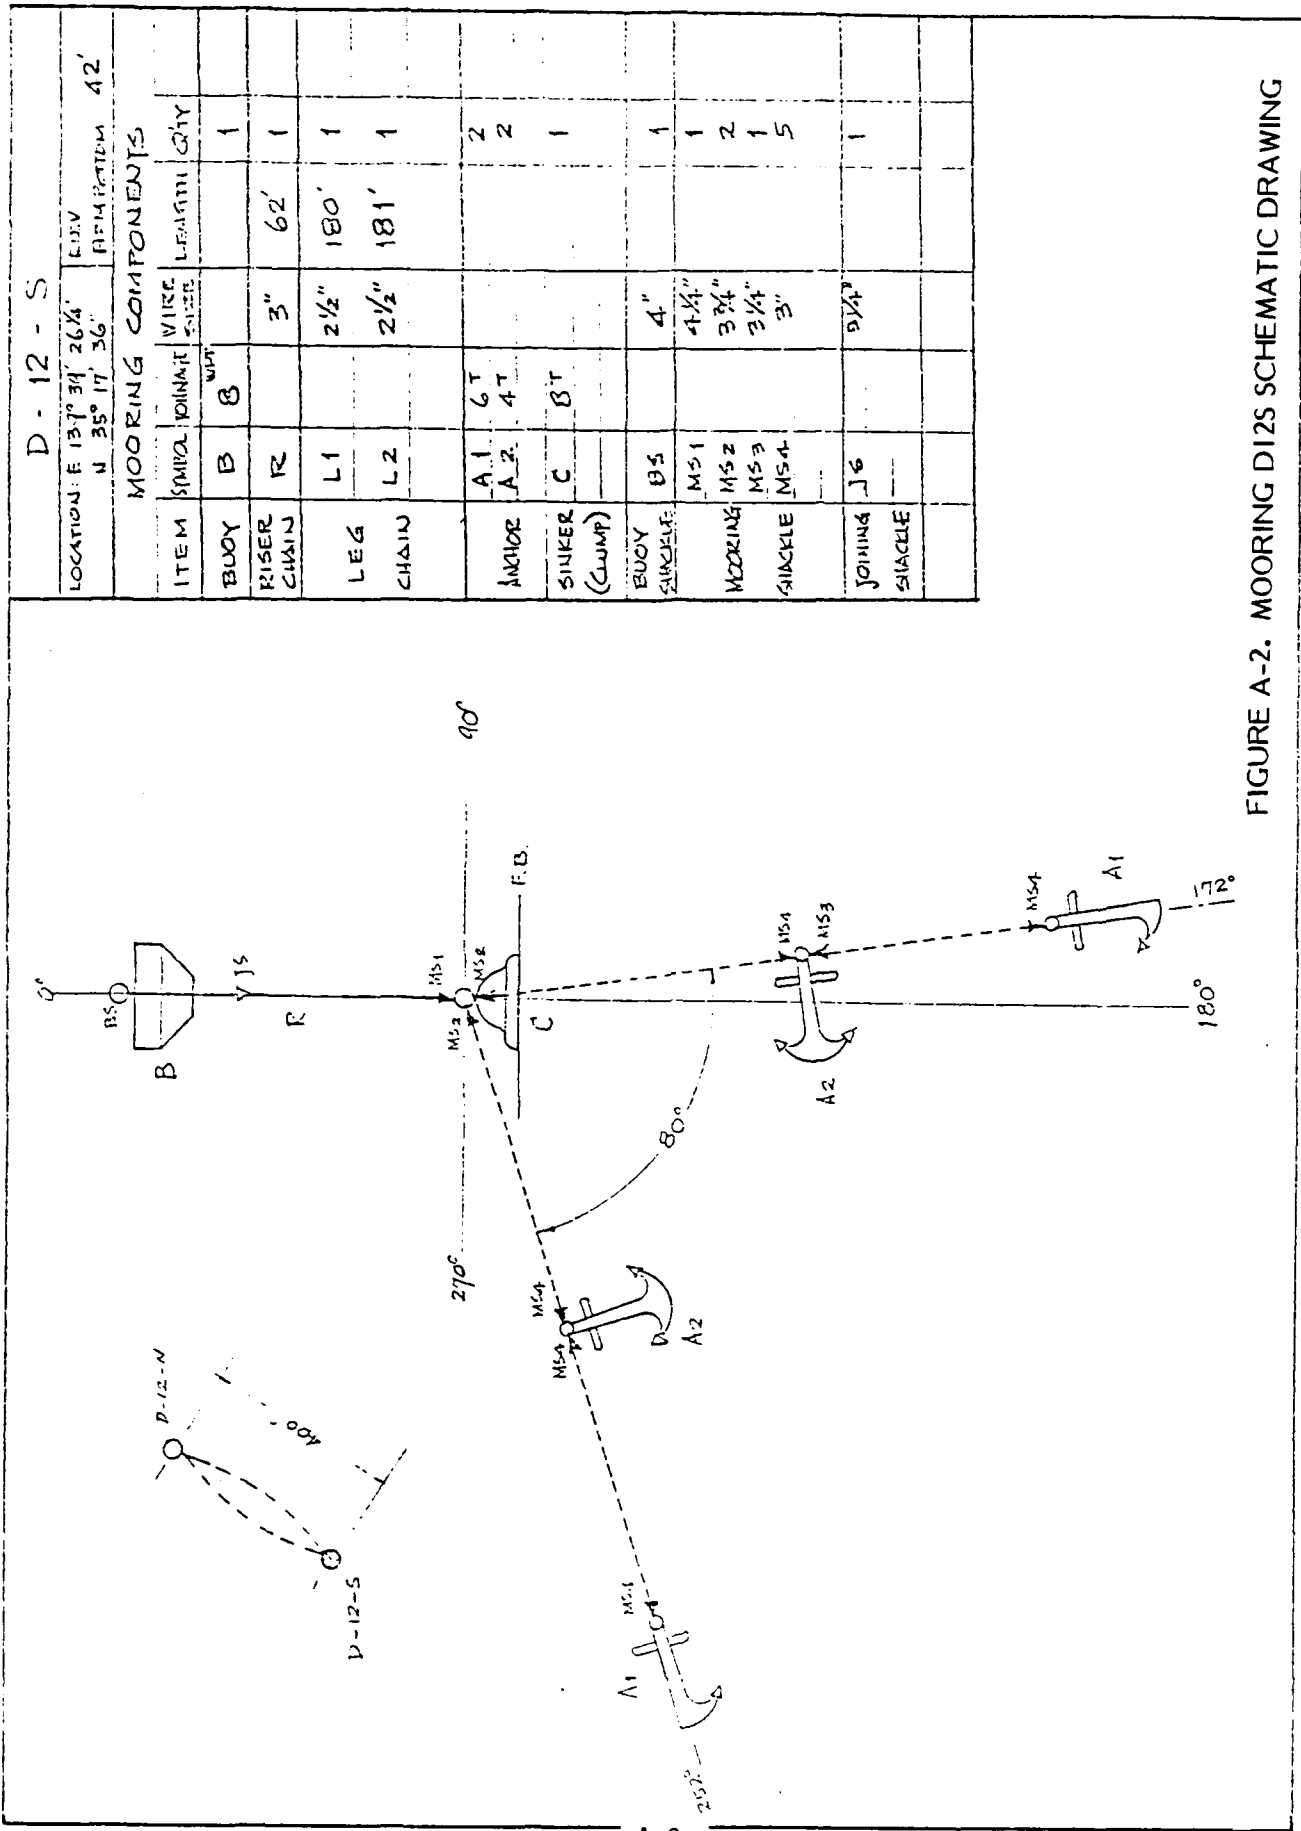
FIGURE A-2. MOORING D12S SCHEMATIC DRAWING

This is a large Japanese-built drum-type buoy with a hawsepipe. The top deck plate, top hardware and hawsepipe are all badly rusted. The buoy is fiberglass coated and has two rubber fenders.

One double link measurement near the mud line was between 80 and 90 percent of the chain's original 3-inch diameter. About 15 feet of rusty riser chain snakes on the bottom before being attached to a cast steel sinker by a 4 1/2-inch shackle. The smallest double link measurement obtained was 5 1/4 inches (87.5 percent).

The upper sections of two ground legs were visible. Leg A was measured and found to have a wire diameter of 2 1/2 inches. This leg and Leg B (which had a single link measurement of 2 5/16 inches) are connected to a cast steel sinker with 4 1/2-inch shackles. A fourth shackle is also attached to the hairpin of the sinker.

This mooring is in fair condition.

As-built information contained in Figure A-2 reveals that the legs of this mooring were 2 1/2-inch wire diameter when installed. A class A mooring requires ground legs of 2 3/4-inch diameter. Therefore, recommend that this mooring be reclassified from a class A to a class B mooring.

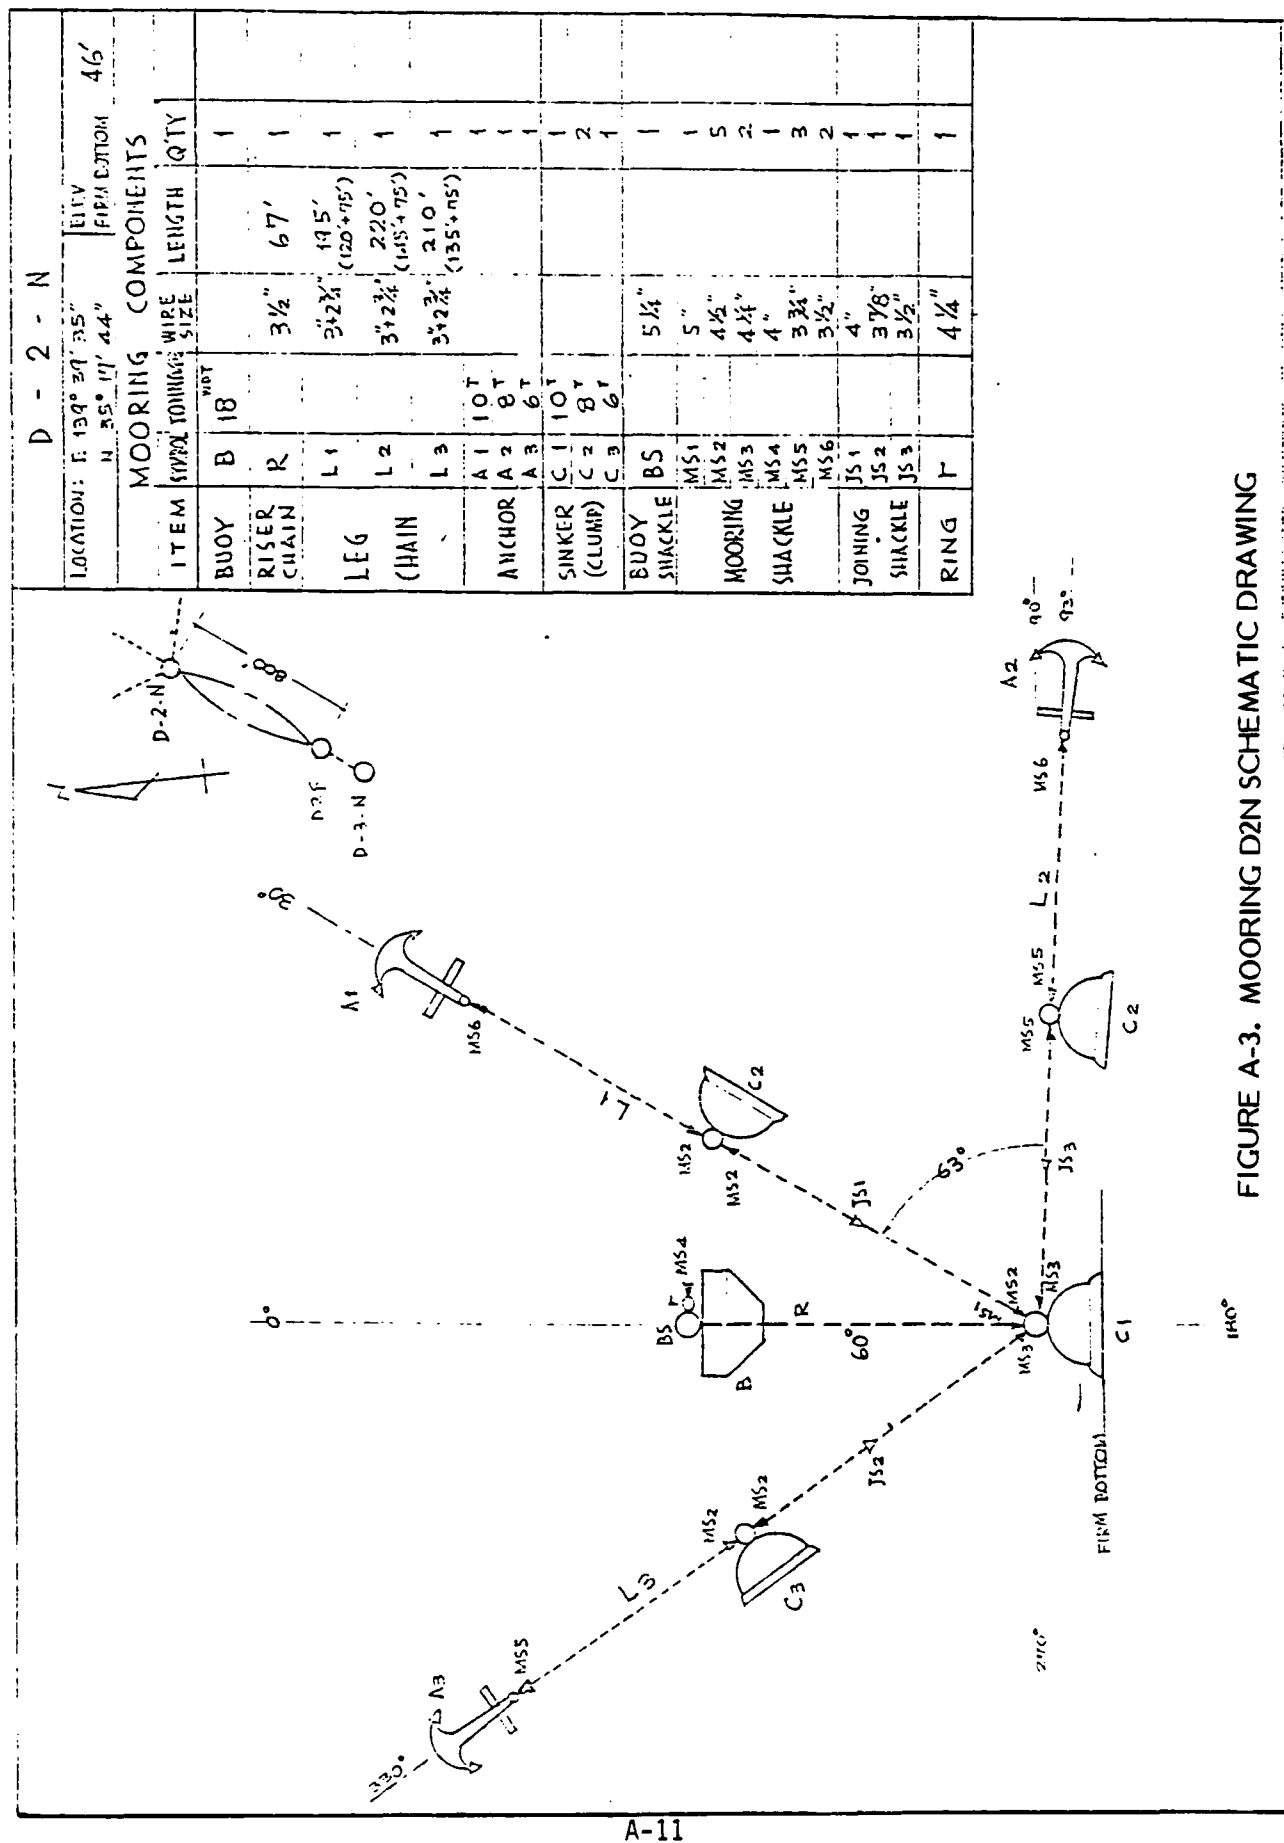
FIGURE A-3. MOORING D2N SCHEMATIC DRAWING

This is a large Japanese-built drum-type buoy with a hawsepipe. The buoy is fiberglass coated. There is some light rusting of the top deck plate under the fiberglass and a medium amount of rust streaking of the side plating. The galvanized pipe chafing rail is rusted and flaking badly. A heavy coating of marine growth covers the buoy bottom below the water line.

This mooring is in fair condition.

The worn condition of the riser chain of this mooring would dictate that this mooring be downgraded to a class A mooring. The ground leg diameters of 2 3/4 inches (Figure A-3) are also satisfactory for a class A mooring. However, this is part of a bow/stern mooring system and its classification should not exceed that of its sister mooring. Since mooring D2S can meet only the requirements of a class C mooring, recommend that this mooring be reclassified to a class C mooring.

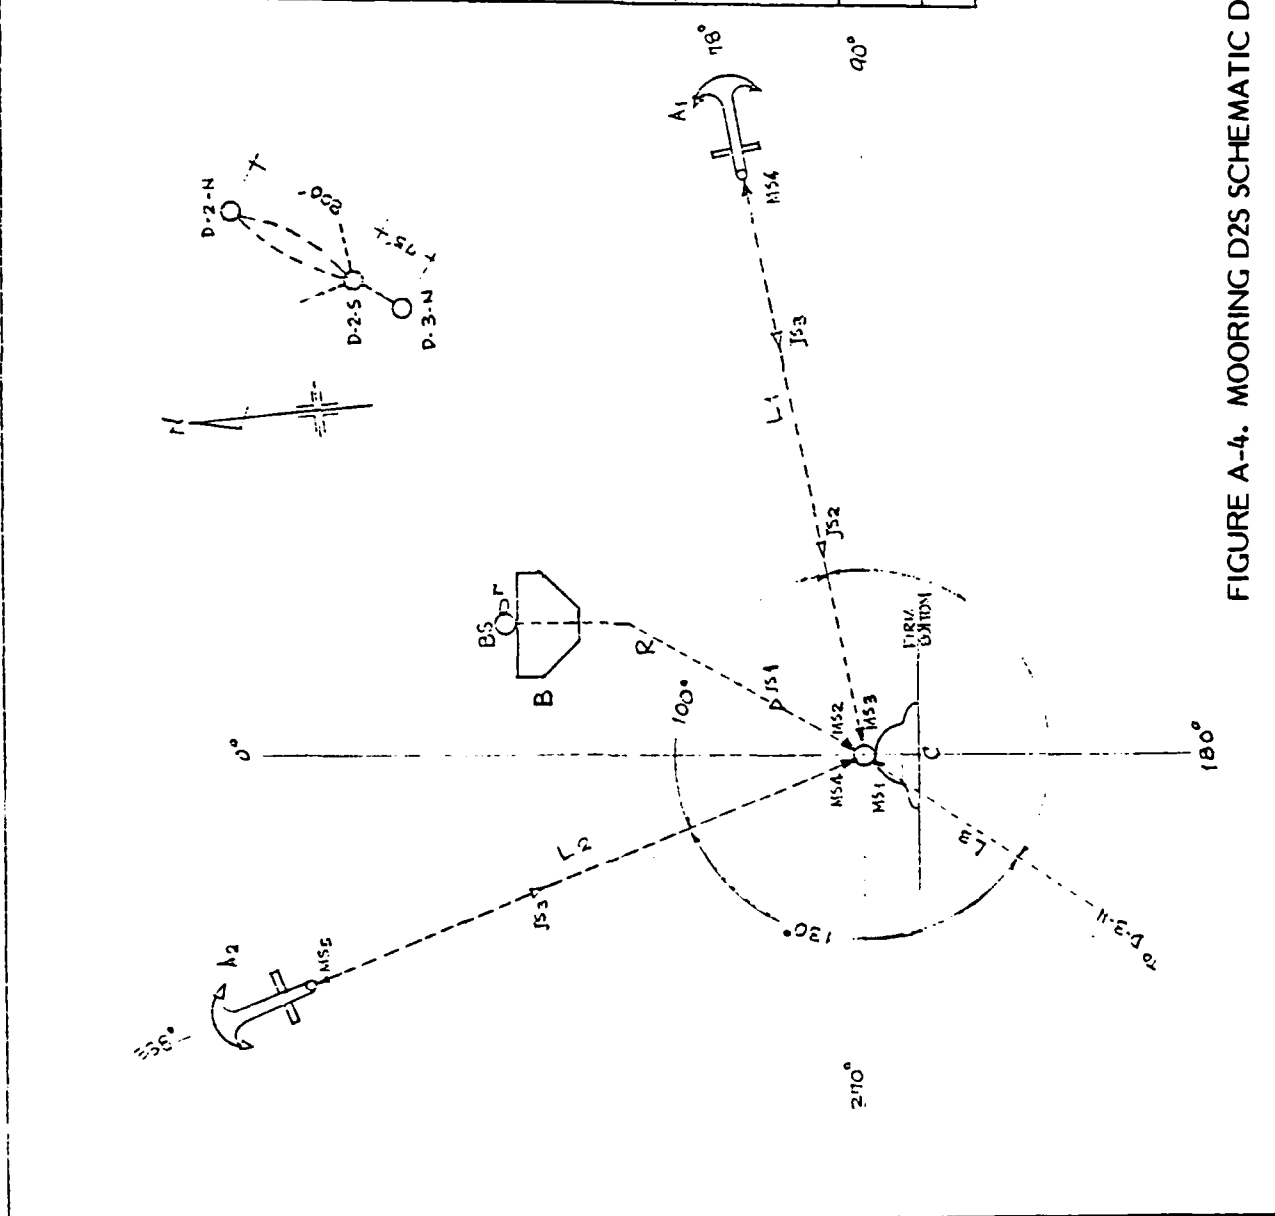
FIGURE A-4. MOORING D2S SCHEMATIC DRAWING

This is a large Japanese-built drum-type buoy with a hawsepipe. The buoy is fiberglass coated, but there is some rusting of the metal hull beneath the fiberglass. There is some green paint near the buoy's water line. Standard paint is black or white.

The riser was originally 3 1/2-inch chain which is now worn to between 80 and 90 percent of that figure near the mud line. The riser enters the bottom at a depth of 46 feet.

This mooring is in fair condition.

The worn condition of the riser chain indicates that this mooring should be downgraded from a class CC to a class A mooring. However, as-built information contained in Figure A-4 reveals that the legs of this mooring were 2 1/4-inch wire diameter when installed. A class A mooring requires ground legs of 2 3/4-inch diameter. Therefore, recommend that this mooring be reclassified from a class CC to a class C mooring.

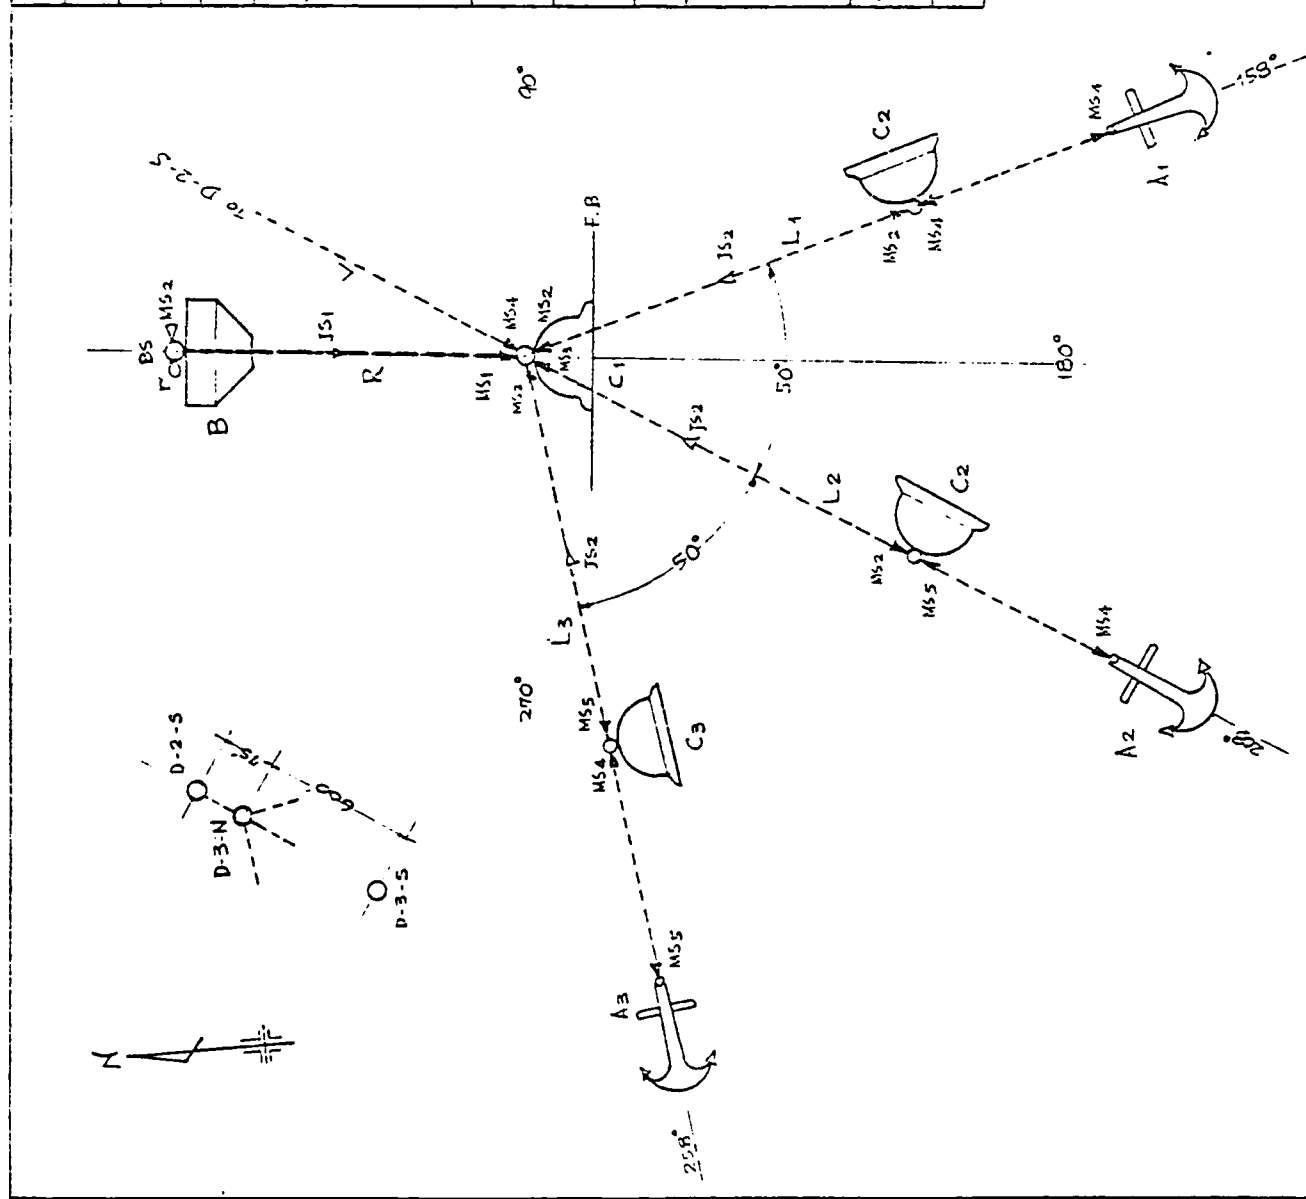
FIGURE A-5. MOORING D3N SCHEMATIC DRAWING

This is a large Japanese-built drum-type buoy with a hawsepipe. The buoy has a 12-foot diameter and is fiberglass coated. The hull of the buoy under the fiberglass is both dented and rusted. The buoy identification numbers need to be repainted and the chafing rail is badly rusted.

This mooring is in fair condition.

As-built information contained in Figure A-5 reveals that the legs of this mooring were 2 1/2-inch wire diameter when installed. A class B mooring requires ground legs of 2 1/2-inch diameter. Therefore, recommend that this mooring be reclassified from a class CC to a class B mooring.

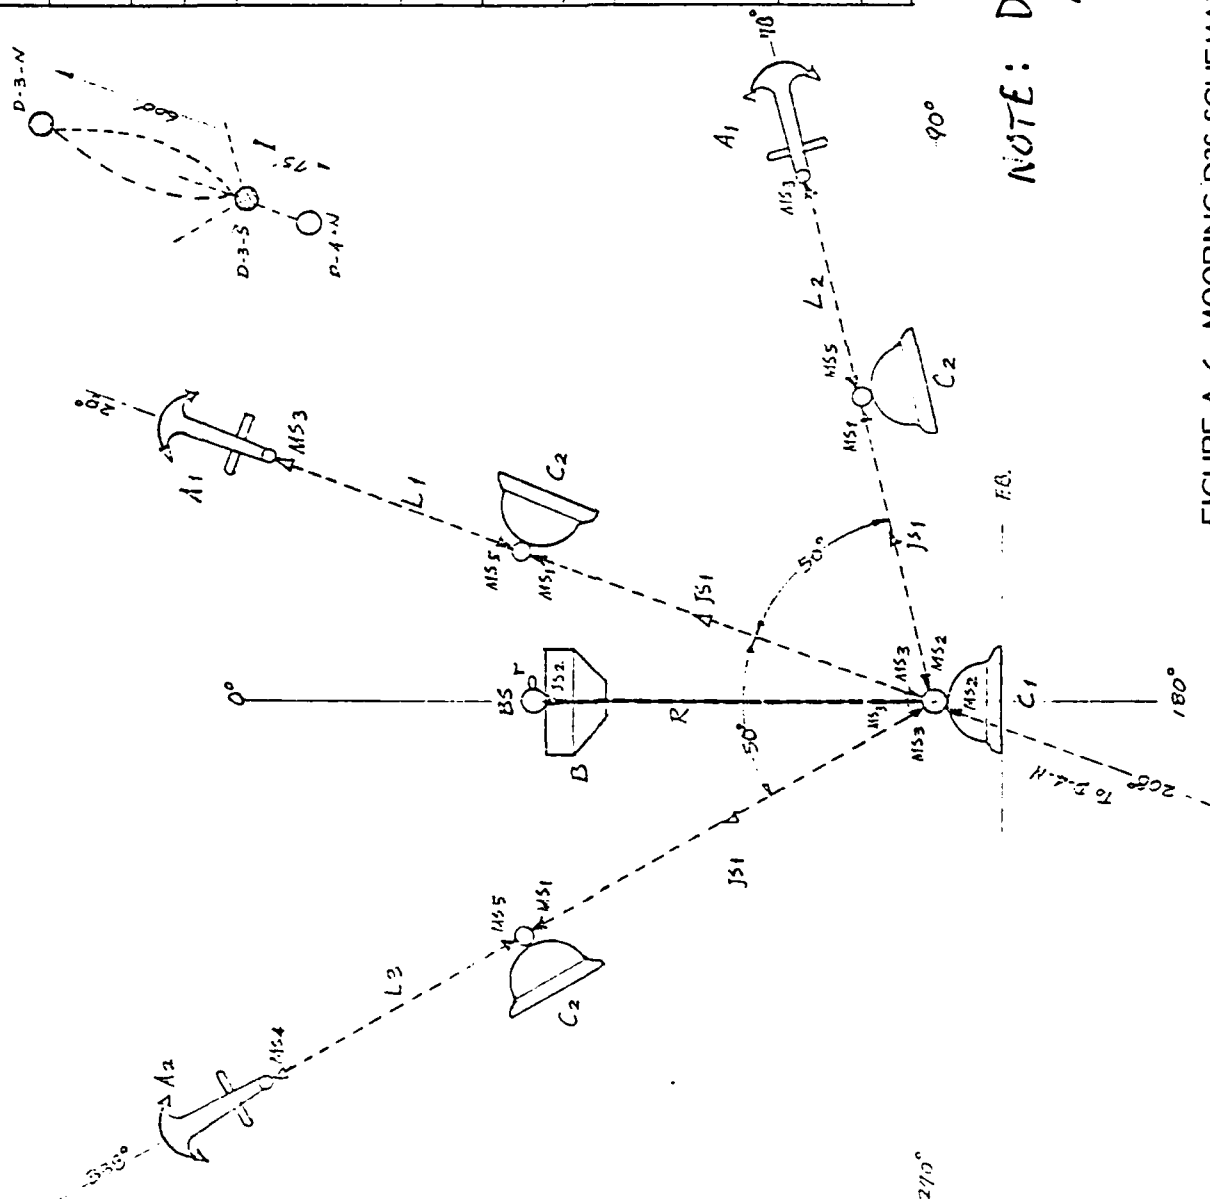
FIGURE A-6. MOORING D3S SCHEMATIC DRAWING

- o Only three of the four ground legs of mooring D3S were found to be connected to the sinker, and their orientation could not be determined. This missing leg could adversely affect the performance of other moorings D3N, D4N, and D4S within the cluster of moorings of which mooring D3S is a part.

This is a large Japanese-built drum-type buoy with a hawsepipe. The buoy is fiberglass coated but its sides have heavy rust bleeding. The pipe-type chafing rail is badly damaged.

This mooring is in poor condition.

NOTE: DIVERS FOUND ONLY THREE LEGS (MAY 1983)

Although Figure A-6 shows that mooring D3S is designed with four ground legs, only three were found to be connected to the sinker. Because this mooring is part of a cluster of moorings (see Figure 2), the missing leg could adversely affect the performance of moorings D3N, D4N and D4S as well. Recommend that the adequacy of this mooring

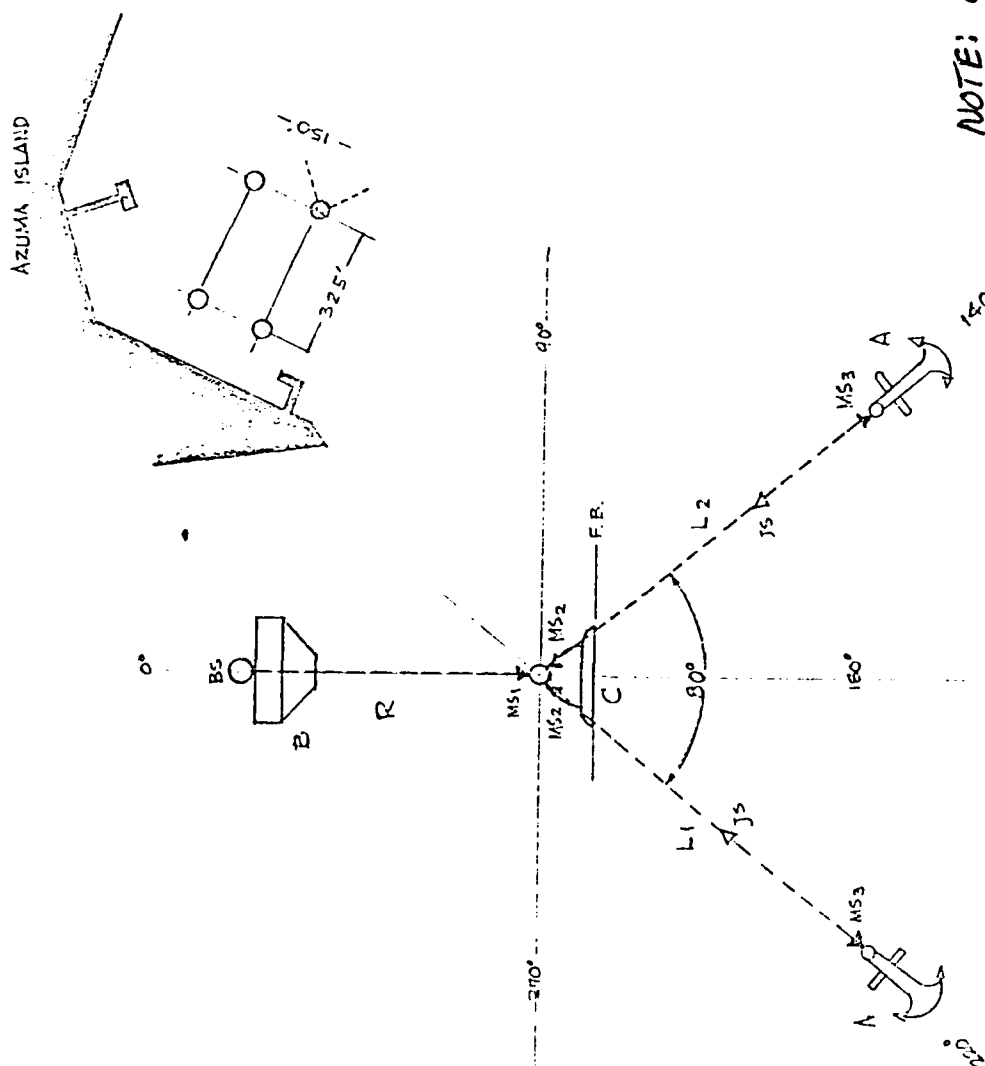
FIGURE A-11. MOORING X-1 SCHEMATIC DRAWING

NOTE: ONE LEG MEASURED 2 1/8" (SINGLE LINK) BY DIVERS - MAY 1987

- o The parallel legs of mooring X-1 should be removed, reoriented, and reinstalled during the next scheduled overhaul.
- o In view of the missing ground leg of mooring D35, recommend that the design of the mooring cluster be reviewed in order to determine the gravity of the loss of this leg on the performance of the overall cluster.

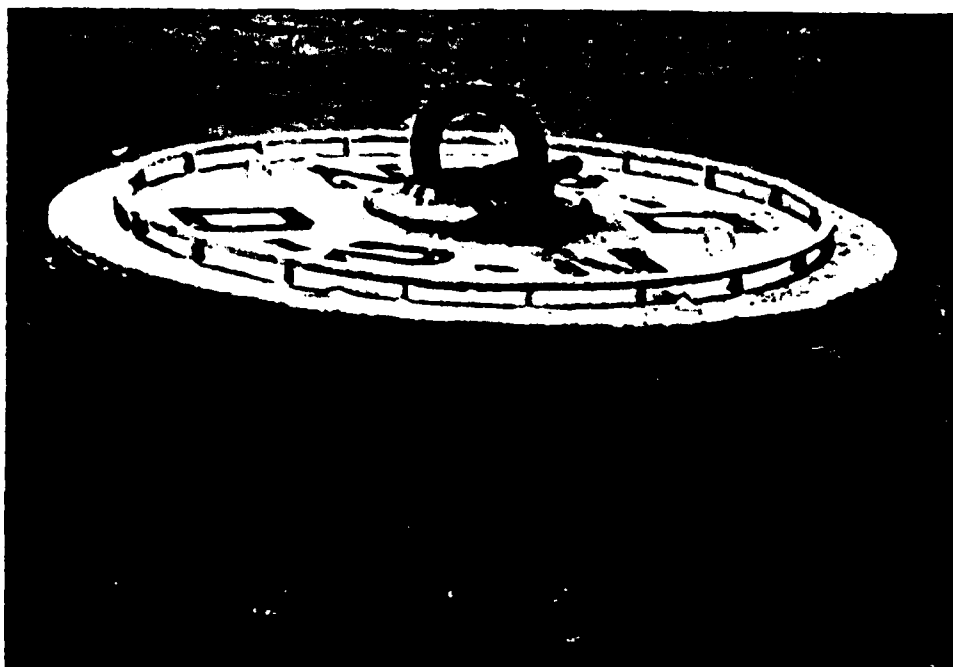
Typical Rust Bleeding Underneath the Fiberglass

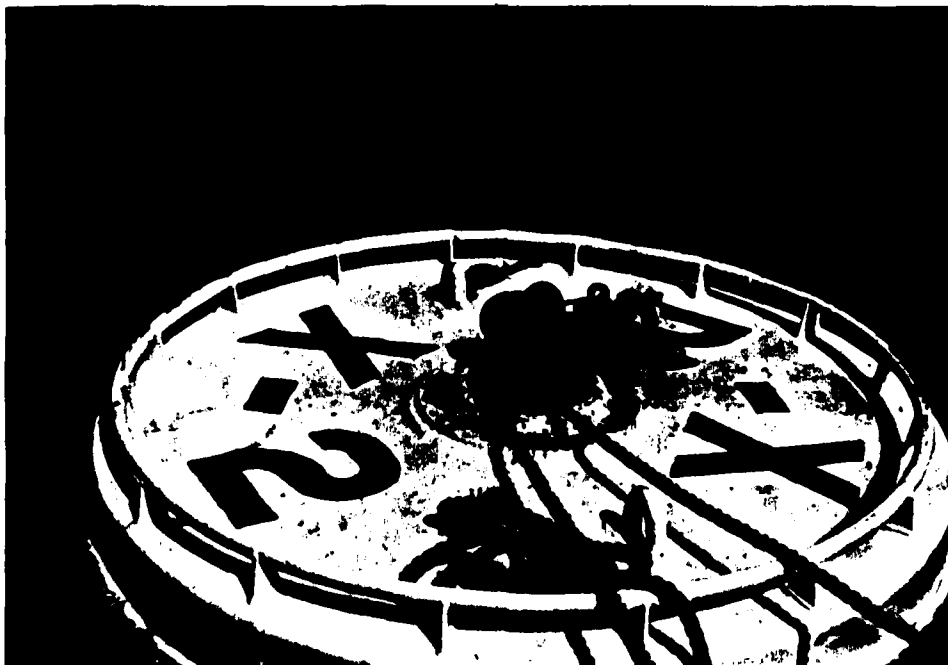
Buoy X-2. Excellent Condition
